REPORT OF INVESTIGATIONS/1994

A Field Trial for Sealing Abandoned Mine Shafts and Adits With Lightweight Concrete

By E. H. Skinner and L. A. Beckett

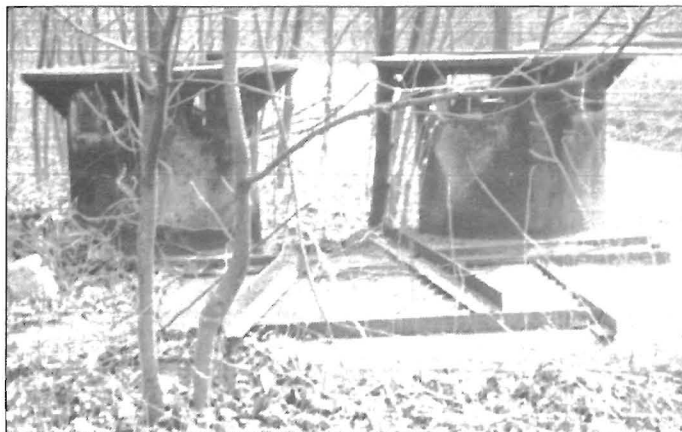
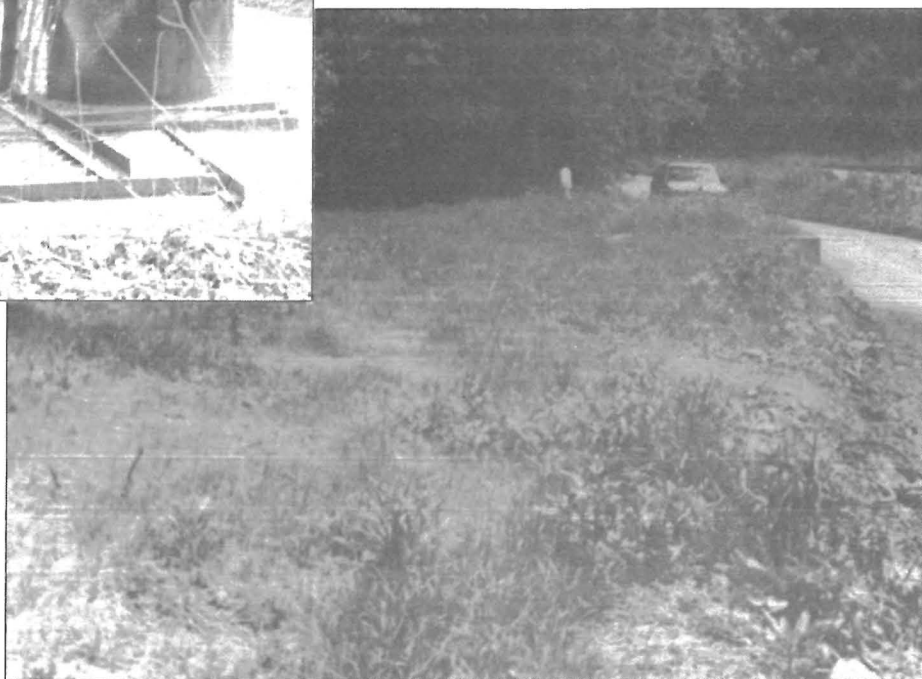
Cover photographs: Site of No. 22 shaft before (top) and after (bottom) shaft sealing project.

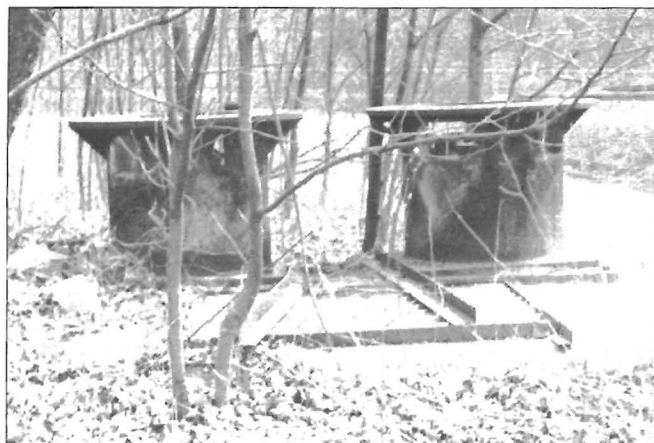
Figure 2.—Shaft site. Remnants of pump housing lie over abandoned shaft.

During the preliminary site reviews with WVDEP representatives, attention was focused on the southern coal fields of West Virginia. It was determined that the mines in Logan County and adjacent counties were representative of abandoned mine conditions in the state. The site selected is known as the No. 22 shaft and is about 5 miles west of Omar, which is about 12 miles southwest of Logan (fig. 1). This site is listed on the WVDEP inventory as site WV-3231. The shaft had been abandoned since about 1968, according to local sources. It was about 300 ft deep, approximately 10 by 10 ft in cross section, and had a reinforced concrete collar that extended about 30 ft below the present ground level. The shaft was connected to extensive underground workings in the Lower Cedar Grove Seam. This prominent seam has been mined in Logan County since the turn of the century (12-14). During the initial site investigation, it became obvious that the No. 22 shaft had been used for water pumping because remnants of pumping equipment were still in place on the surface (fig. 2). However, the deteriorated condition of the

As mentioned, initial inspection of the No. 22 shaft site revealed the deteriorated condition of the surface concrete and the extraordinary amount of vegetation regrowth (figs. 2-3). Construction required that the original concrete cap and concrete collar be removed, and both were ultimately excavated to a depth about 2 ft below the initial collar height.

Surface remnants of the original pump housing, including the attached shaft utilities, were in place at the start of this project (figs. 2, 9). The surface-mounted electric motor frames were attached to pump lines that extended throughout the entire vertical length of the shaft. One line lay on each side of the shaft and consisted of a 12-in-diam steel pump line with an inner 3-1/2-in-diam solid steel shafting of hardened steel. A buried electrical line was also discovered during excavation for the footings.

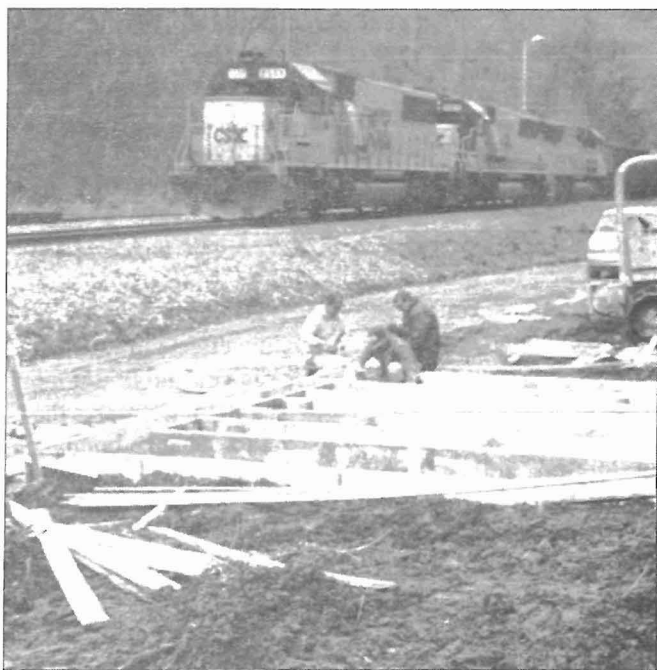
Figure 5.—Railroad and county road traffic along shaft site. Shaft cover is being prepared as safety precaution.

A primary design objective was a shaft seal with a design life of at least 100 yr. Many factors other than the primary shaft seal design were, therefore, considered. Presently, active surface coal operations are mining multiple seams about 3 miles west of No. 22 shaft. The railroad along Pine Creek servicing these mines carries at least two 100-car coal trains per week (fig. 5). The county road adjacent to the shaft site is also heavily traveled, and large mining equipment, often requiring the use of an 18-wheel trailer, is hauled on it.

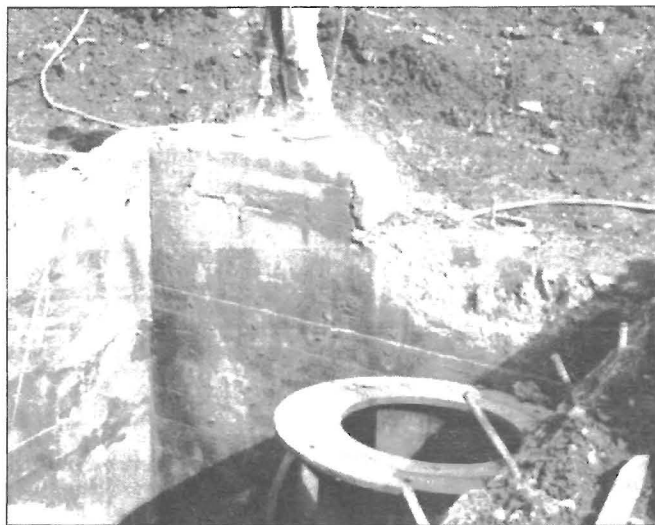
Figure 8.—Removing original concrete shaft collar with jackhammer.

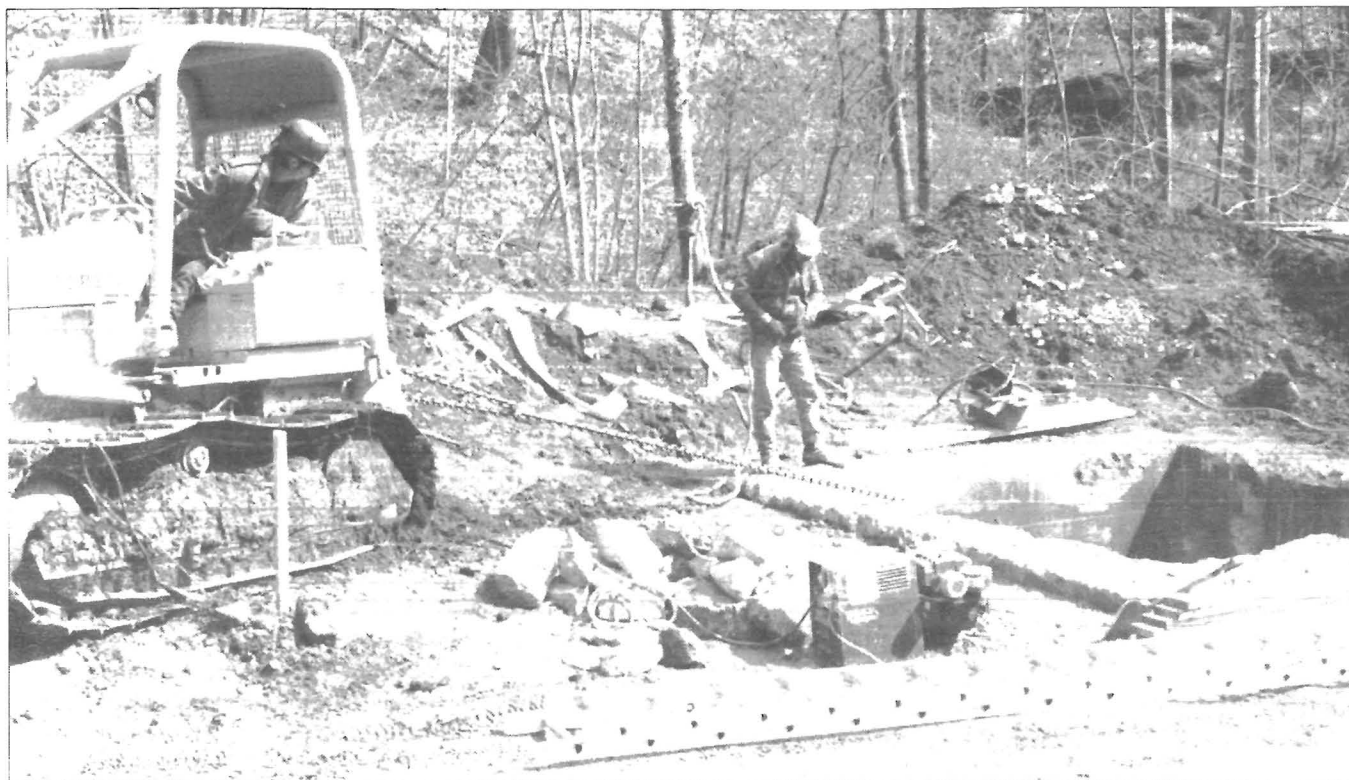
Figure 10.—Removing shaft utilities after removal of shaft collar.

Removal of shaft utilities was done in two stages: the removal of surface equipment and debris, and the cutting away of pump lines and shafting within the shaft to a depth of approximately 12 ft below the collar. No materials were salvaged. Removing the shaft utility lines was completed in conjunction with the removal of the concrete collar (fig. 10) and was extremely hazardous.

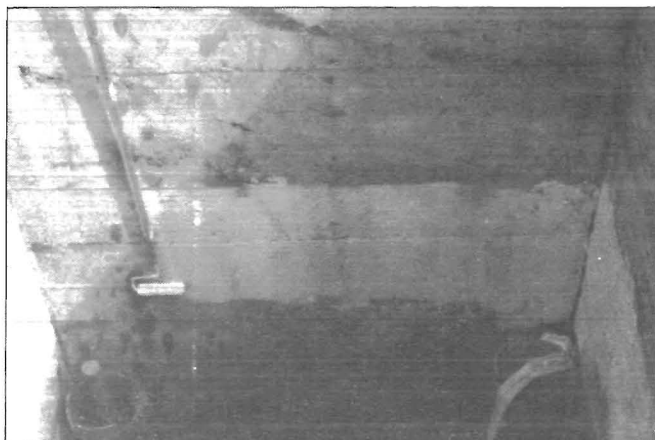
Figure 11.—Applying waterproofing coating. This was done after original shaft walls had been power washed and shaft utilities removed.

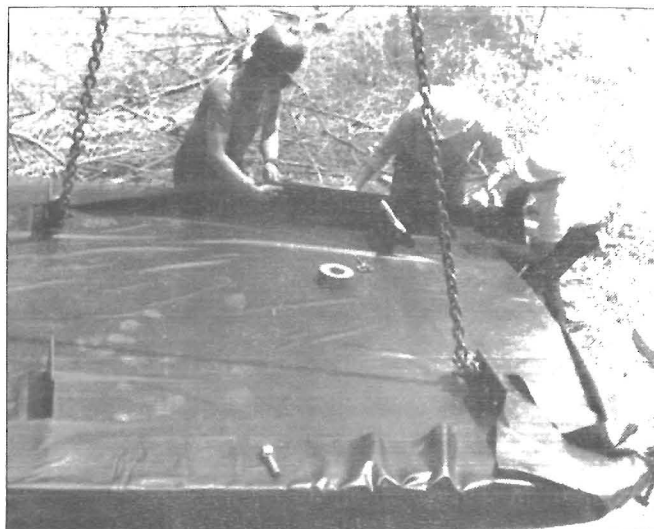
Figure 12.—Applying geomembrane covering to shaft platform.

The platform was painted in the field with two coats of corrosion-resistant, industrial-grade paint before wrapping with Hypalon geomembrane. The Hypalon fabric was supplied in one large sheet for the bottom wrap and a smaller sheet for the top wrap. Strips of Hypalon were used to seal the joints between the platform and the shaft walls. Manufacturer-approved glue was used on all joints (fig. 12). Wrapping and sealing the platform with geomembrane in the field was considered very successful (fig. 13).

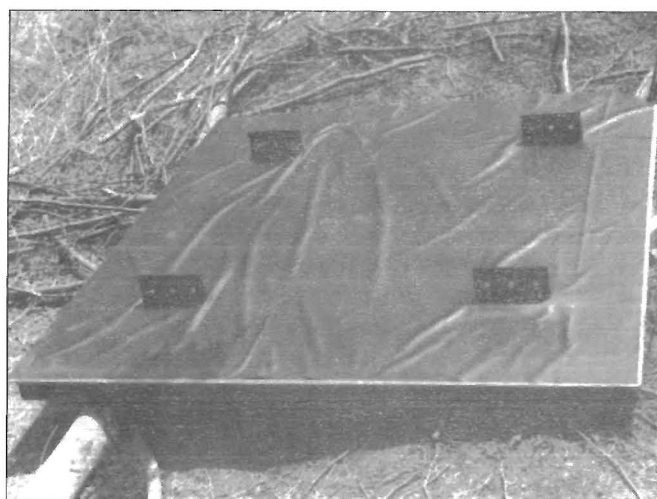
Figure 13.—Shaft platform wrapped with geomembrane.

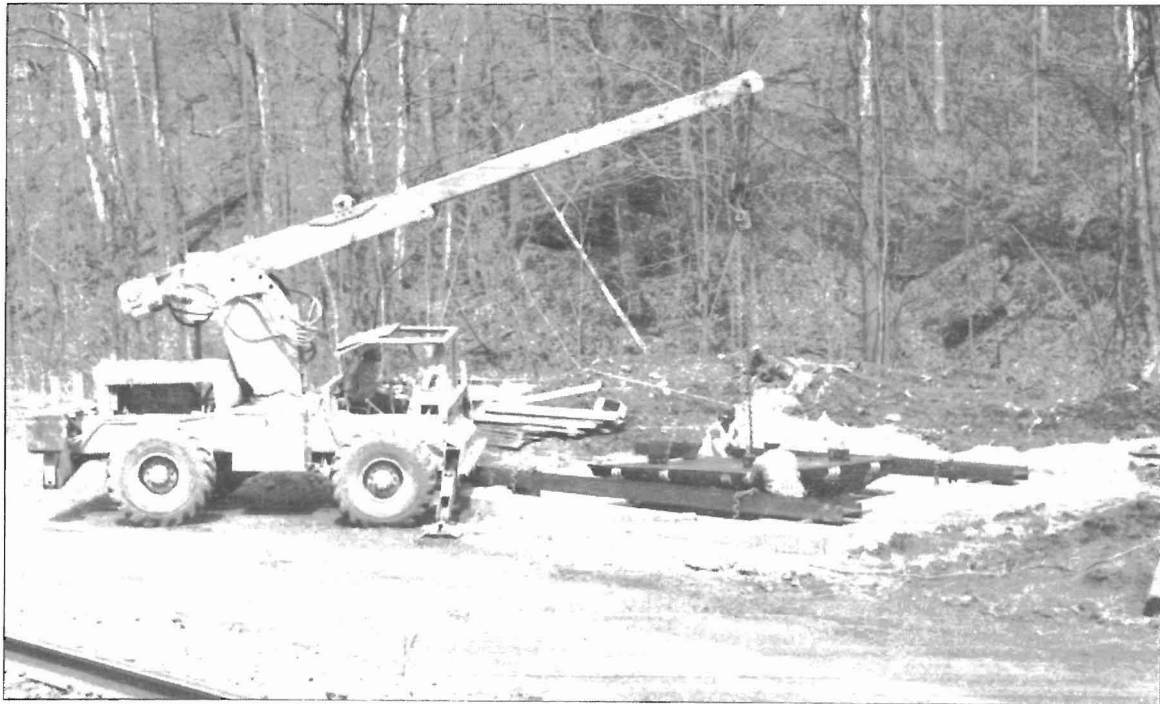
Figure 15.—Platform being lowered into shaft. Note beams in place alongside shaft.

After covering the platform with the geomembrane, the platform was moved to the shaft, the tie-rods and chain were attached, and the entire assembly was lowered into the shaft without incident (fig. 15). Adjusting the chain positions on the beams, so that the weight became equally distributed, completed the installation. Within the shaft,

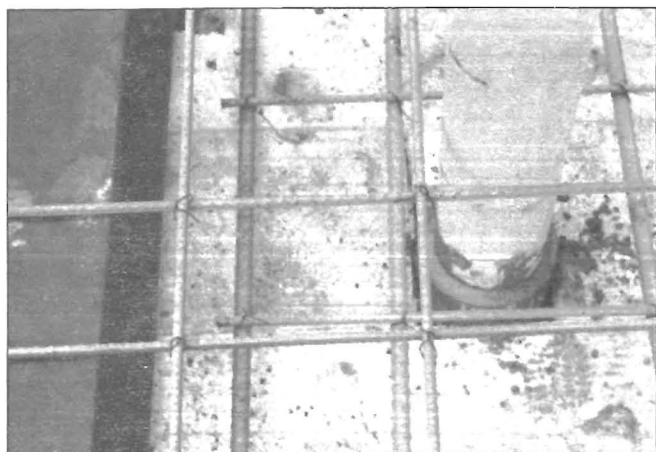
Figure 25.—Detail of vent tube placement. Upper tube is shown inside sheathing tube, which extends completely through lightweight concrete core.

placed in the corner of the shaft farthest from the county road to prevent possible vehicle disturbance and to serve as a permanent marker. The design called for the vent tube to be in telescoping sections. A sheathing tube completely penetrated both the lightweight concrete core and the normal-weight concrete cap. The lower sheathing tube, which extended from approximately 1 ft below the platform assembly within the shaft upward through the core to just below the steel beams, was 8 in. in diameter and 11 ft long. The second tube was designed to allow for possible movement or settling between either the top slab or the lightweight concrete core. This tube was a 15-ft section of 6-in pipe placed within the 8-in sheathing tube. Approximately 3 ft extended above the ground surface. The connection was hand-packed with concrete just above the lightweight concrete (fig. 25). All vent tube piping was polyvinyl chloride (PVC), schedule 40, ASTM D-1785. To

provide surface protection and prevent vandalism, an 18-in length of 8-in-diam steel pipe¹¹ was placed around the protruding PVC pipe and embedded about 1 ft deep in the fresh concrete of the top surface slab. The joint was hand-packed with concrete (fig. 26). An additional PVC section with an elbow joint and flame arrestor was later installed on top of the 6-in pipe.

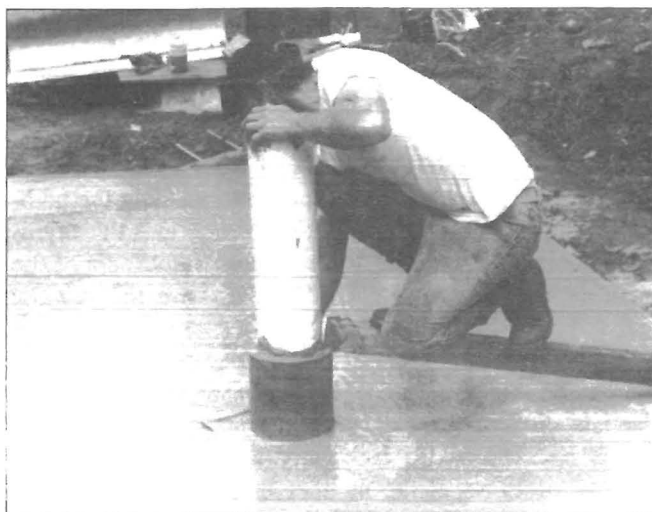
Figure 26.—Hand-packing grout between protective steel casing and vent tube.

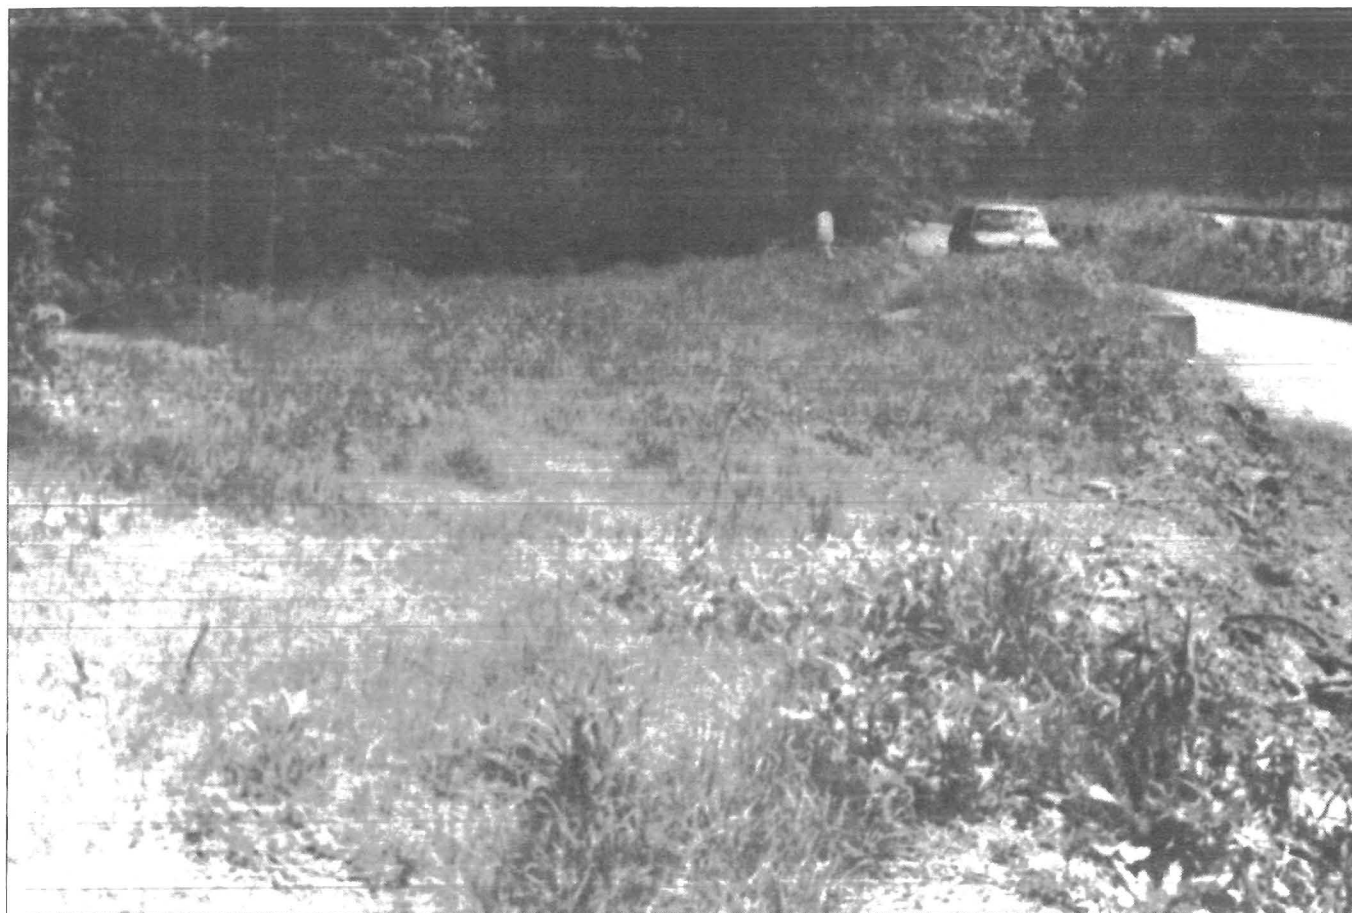
Figure 27.—Vegetation growth on shaft site after landscaping and grass seeding.

Seeding schedules depended on the season. Spring seeding required a mixture of 15 lb/acre of annual ryegrass, 40 lb/acre of tall fescue (KY-31), 15 lb/acre of birdsfoot trefoil, and 20 lb/acre of crown vetch. All seed was certified and properly inoculated for growth. Mulching was done immediately following seeding. The WVDEP contract made the contractor responsible for the site for 1 yr following project completion, during which time reseeding or further reclaiming might be necessary if erosion occurred. The vegetation growth approximately 8 weeks following project completion is shown in figure 27.
